ThunderEnlightening^{T.M.}

A NEWSLETTER FOR THE CLASSIC THUNDERBIRD OWNER AND RESTORER

ISSUE NUMBER TWENTY-TWO • NOVEMBER 2009

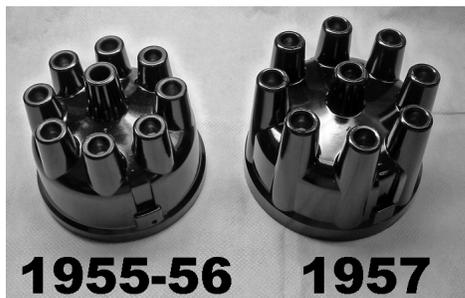
Additionally, as the following pictures illustrate, there were differences in the distributor cap, points, and rotor. The distributor cap for the 1955 / 1956 distributors is 3-1/2" in diameter and has a small hole through the lower side and a tab on the inside rim. The 1957 distributor cap is 4" in diameter and has a locating notch cut out of the rim.

easiest method is to look at the external vacuum advance diaphragm. The 1955 distributor had a larger single diaphragm, approximately 4 inches in diameter. The 1956 had a dual diaphragm. While the 1957 had a smaller single diaphragm vacuum advance, approximately 3 inches in diameter.

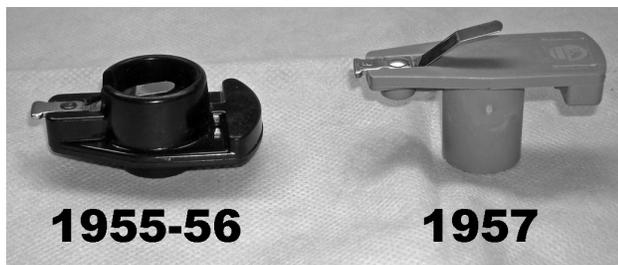
The rotors were entirely different shapes as can be seen in the following picture.

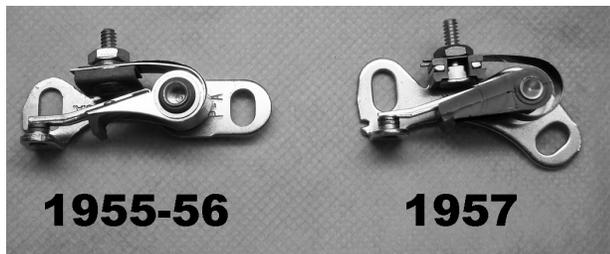
The base of the points for the 1955 / 1956 is pretty much a straight line while the 1957 points base takes quite a dogleg at each end.

As you can see, most of the parts for these two distributors are not interchangeable. The condensers are also different, but look the same externally.

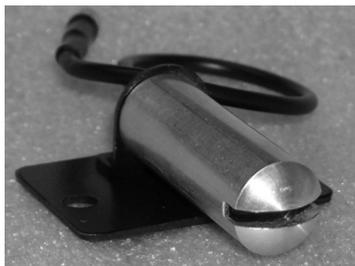
CASCO has now manufactured the newly available **Ford-O-Matic shifter light assembly**, part number 15A801. The cover is a one piece machined aluminum part. Bulb is not included. Used on 1955, 56 & 57s. Price is \$27.89 plus S&H.

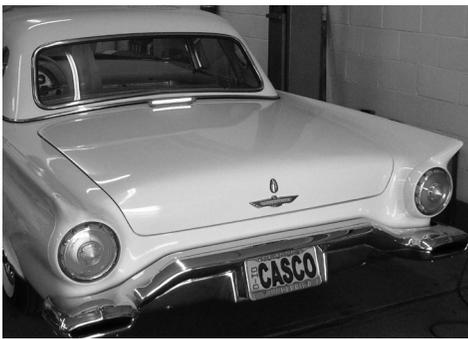
THIRD BRAKE LIGHT NOW AVAILABLE FOR YOUR T-BIRD

For some time now we have been working on a third brake light for use on your classic T-Bird. We are proud to announce that we have designed a wonderful LED

third brake light which looks good and is very versatile.

This lamp adds a level of visibility which increases the safe operation of your classic car. The unique design allows temporary and semi-permanent installation without making any permanent changes to your vehicle. In fact, if you purchase extra wiring harnesses, you are seconds away from moving your lamp assembly to any of your classic cars!

Designed to fasten to the rear of your trunk lid with either suction cups, or double sided foam tape. Supplied wiring harness taps into your car's stoplight circuit without cutting or splicing your original wiring. Lamp module is shipped in primer. You paint to match or coordinate with your vehicle. Kit includes LED module, wiring harness, suction cups, double sided foam tape, and instructions. Kit is part number 13467A @ \$124.95 plus S&H. Extra wiring harness part number 13467H @ \$34.95 plus S&H.
